# Independent Building Inspection Report (Pre Purchase Comprehensive)

Complies with Australian Standard AS 4349.1-2007

Inspected by:	Arthur Bell (Building Reg. Number - 14236)
Date of Inspection:	Wednesday, 18 October 2017
Customer Name:	Mr A.N Other
Property Address:	22 Happy Valley Nice Town WA
Job number	ABE 1715

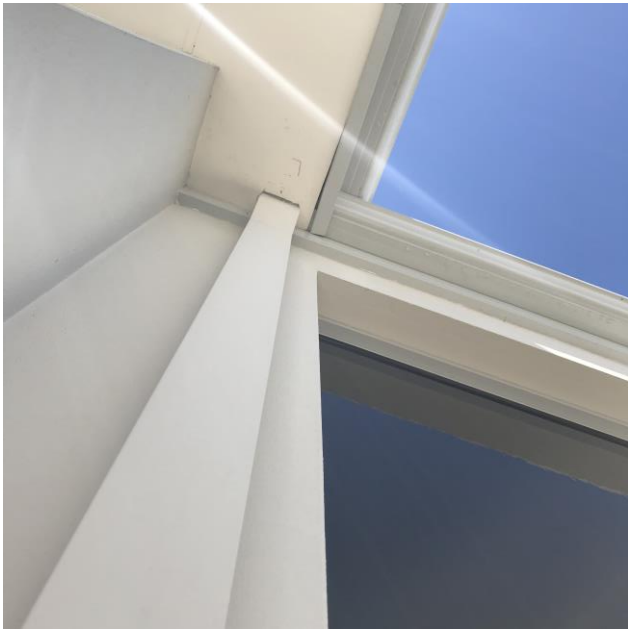
- a. The bargeboard to the rear of the garage would benefit from being correctly painted.
- b. The fascia to the return nib on the North elevation has moved away from the eaves sheet. This should be pushed back into place.

4.1.1b. Roof External fascia movement

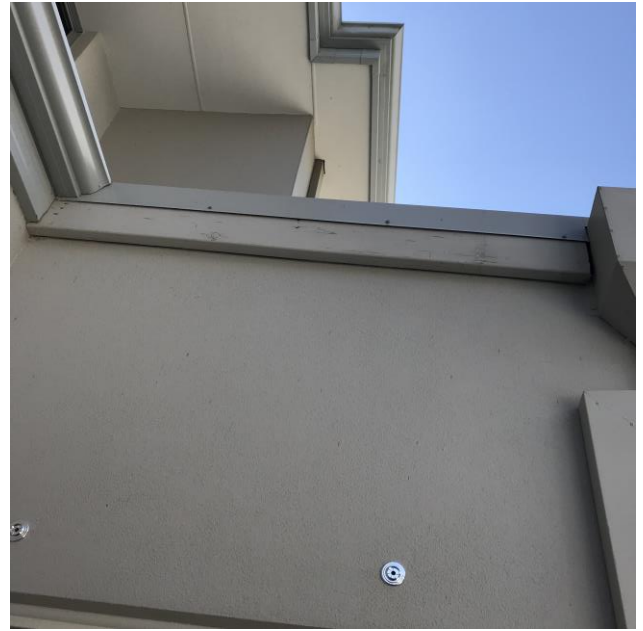
4.1.1a. Roof external Bargeboard

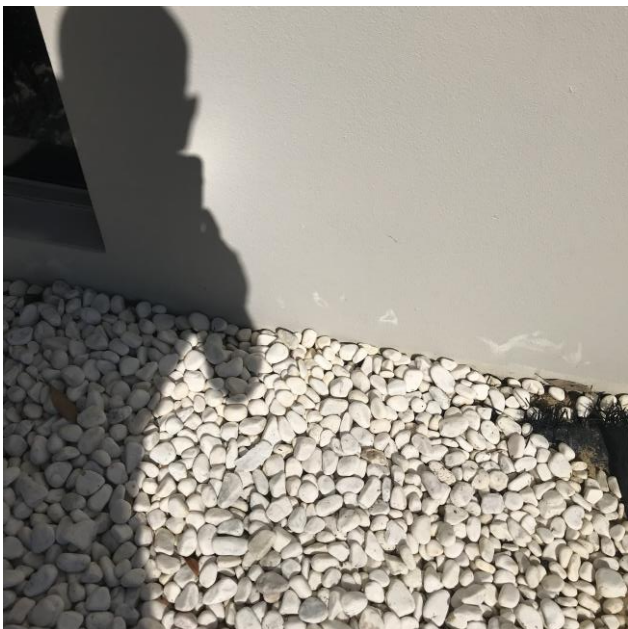
4.2.1a. Weepholes

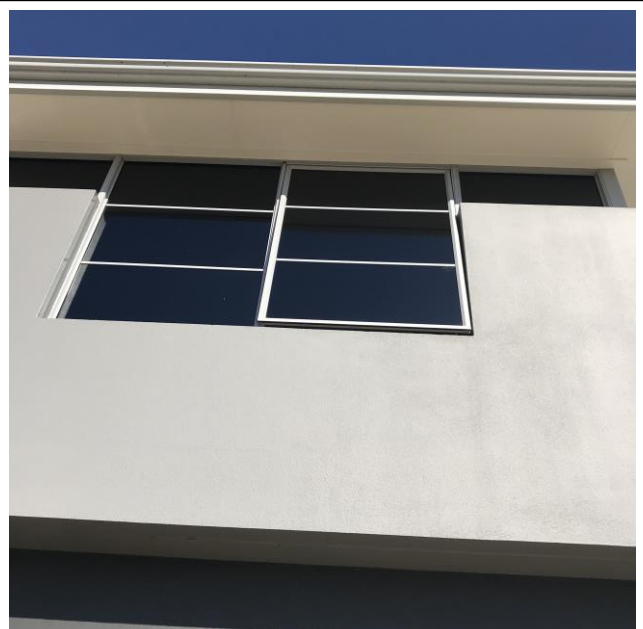
- a. It was noted that no weepholes are apparent at paving level this is not an Australian standard however it is good building practice to have them.
- b. It was noted that no weepholes are apparent at first floor slab level. The AS 3700 – 2011 section 4.7.2 suggest that weepholes should be spaced around areas which have cavity flashings not more than 1.200 centres. This is classed as BCA not compliant.

4.2.1b. Weepholes

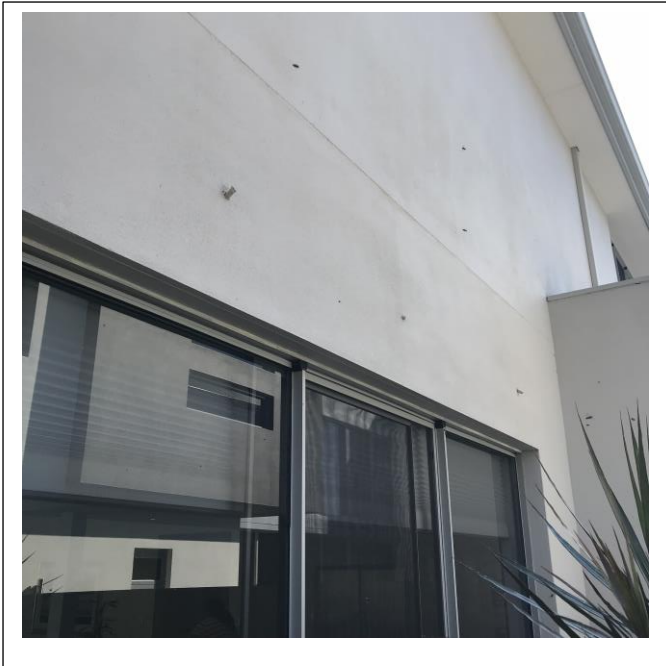
- c. It was noted that weepholes had been installed above the windows and a tidy cover has been used to make the weepholes aesthetically pleasing however the weepholes above the dining area on the South elevation have not been tidied up and are protruding the render.

4.2.1c. Weepholes

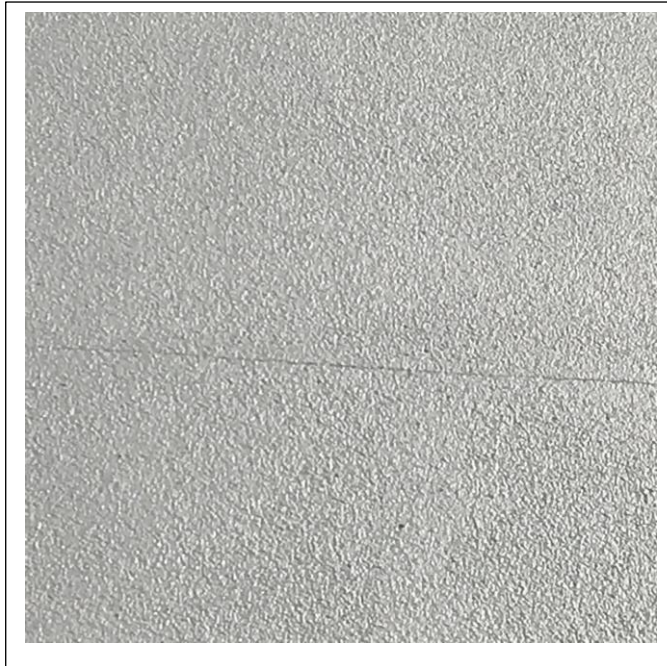
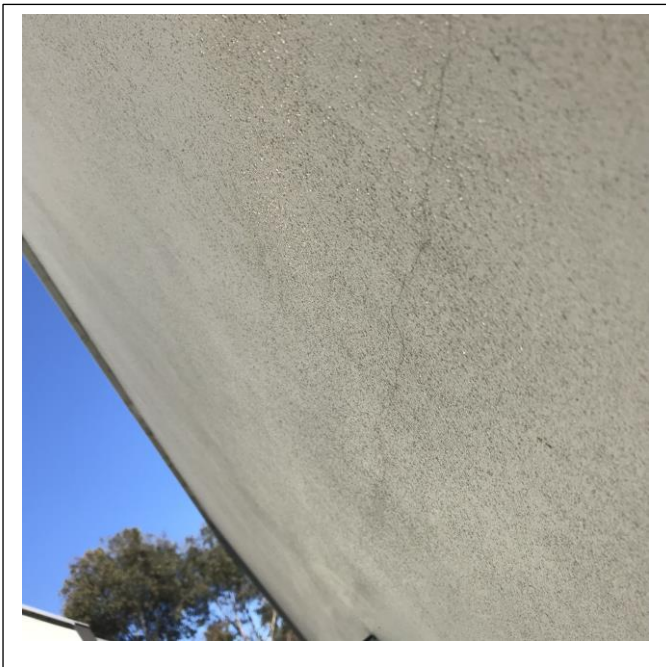
- d. Cracking to render in various areas. This is deemed to be shrinkage cracking only and classed as a minor defect.
- e. Some paint missing from the render to the top of the service duct stack on the North elevation and the return roof nibs to the lounge area.

4.2.1d. Minor cracking

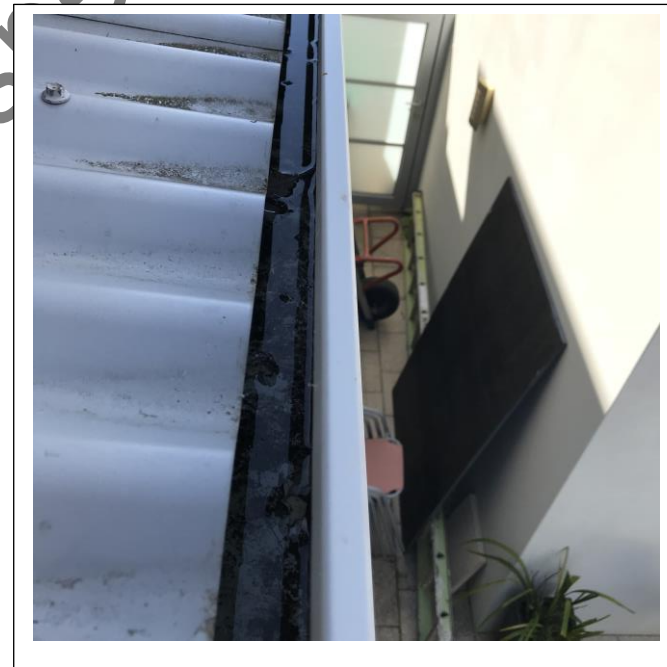
- a. Some water lying in the gutters to the alfresco and kitchen areas South elevation. Because gutters are installed level in WA this occurrence is common and not deemed as a fault. Check gutters regularly to ensure they are kept free of vegetation.
- b. Downpipe direct base connection to rear of garage appears to be faulty causing an area of the soil below the paving to erode. Repair fault and make good eroded soil.

4.3.1a Gutters

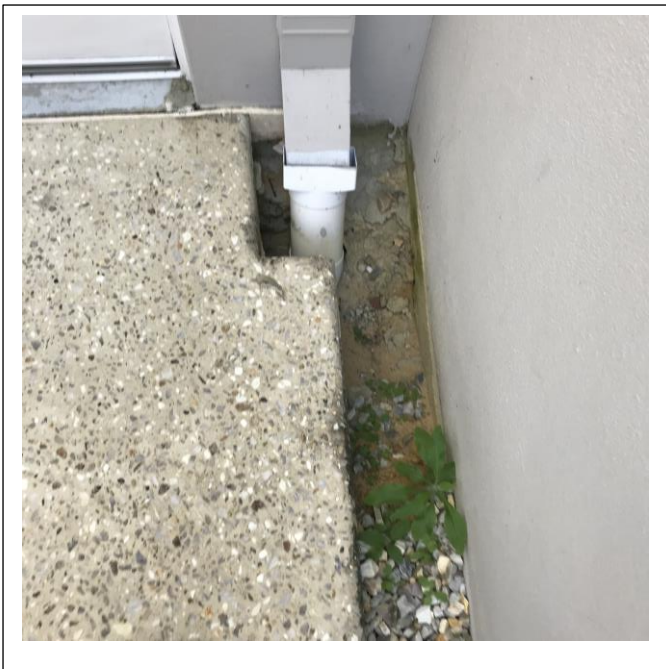
4.3.1b. Garage downpipe

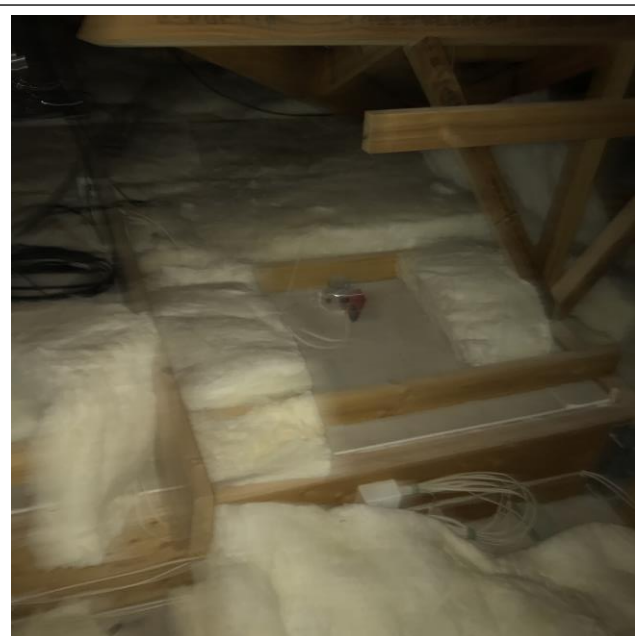
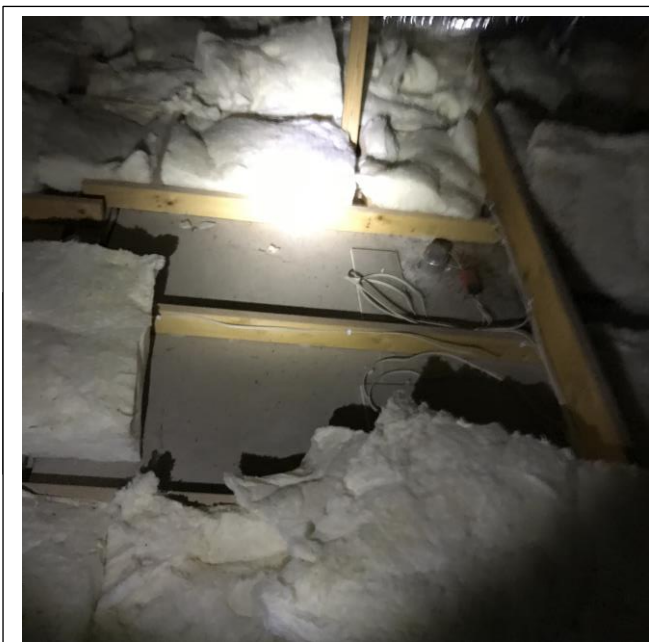
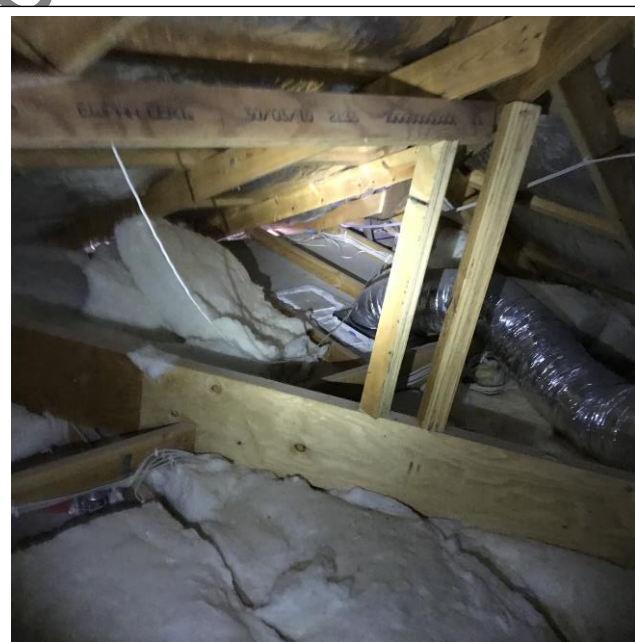
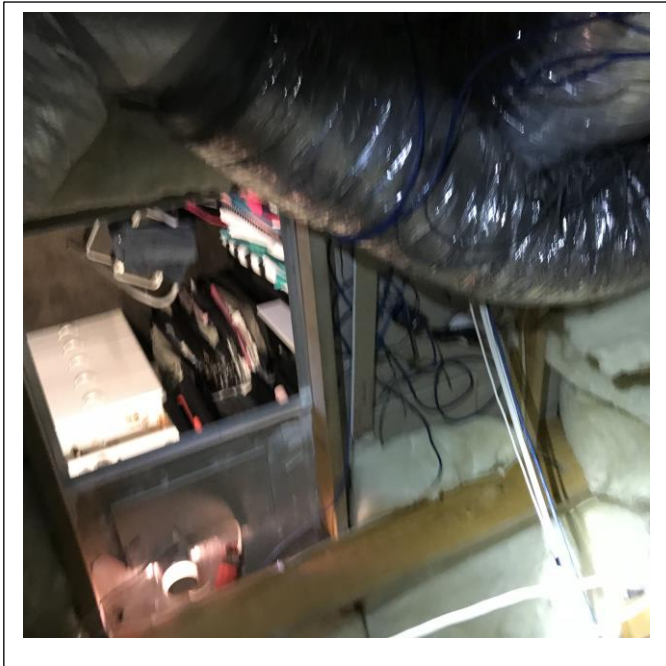
- a. It is evident that the insulation currently installed needs to be adjusted so it abuts the structure of the building and its members (ceiling joists). It is currently scattered and not uniform. This is non-compliant with the BCA part 3.12.1.1.
- b. Manhole will benefit from being structurally framed on all four sides. Currently only two sides have timber framing.
- c. One of the collar ties spanning between 2 common rafters is broken and requires replacement. In its current state it does not meet AS 1684.2 2010.

4.4.1a. Insulation

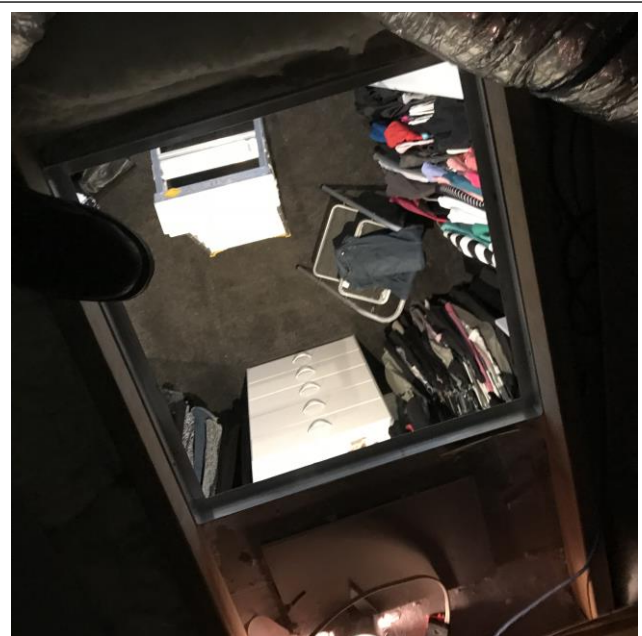
4.4.1b. Manhole access frame

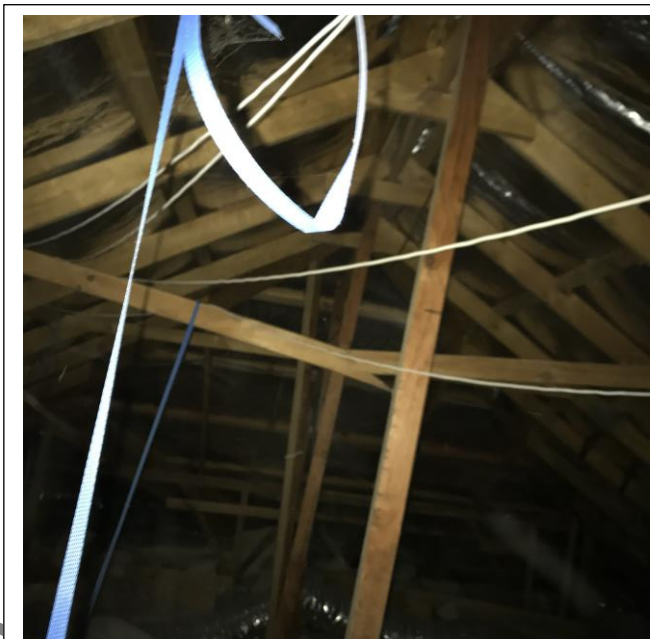
4.4.1c. Collar Ties

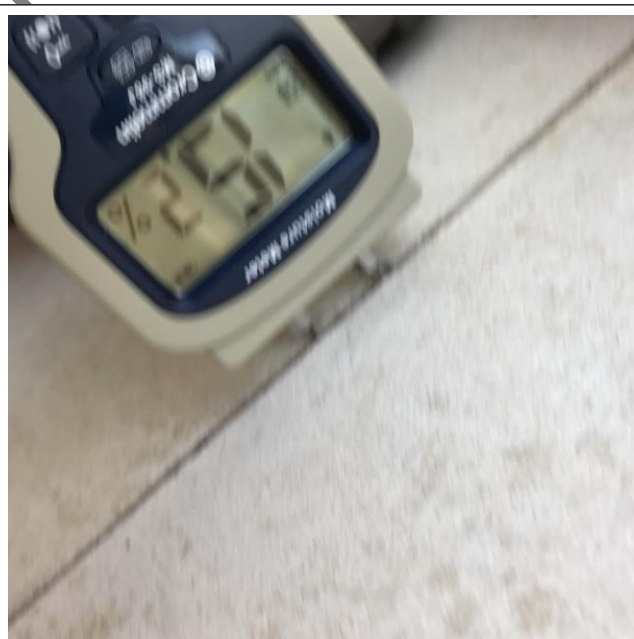
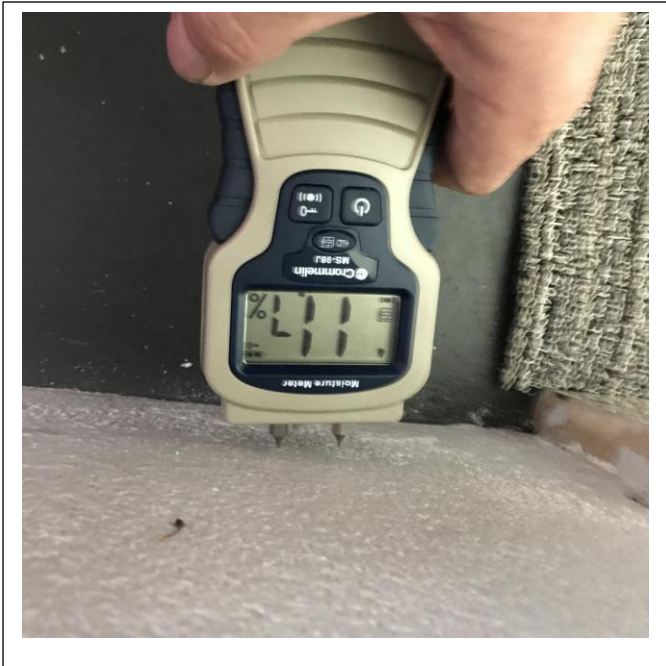
- a. Some dampness shown up on the damp meter to the floor of the alfresco directly in front of the West facing sliding external door. I believe this is because the window and slider drainage holes externally have been covered by the high paving. Because this area although being internal is classed as an uninhabitable area and not covered by the same legislation as the habitable areas of the house.

4.7.1a. Dampness to floor in alfresco

4.7.1a Sliding door to alfresco

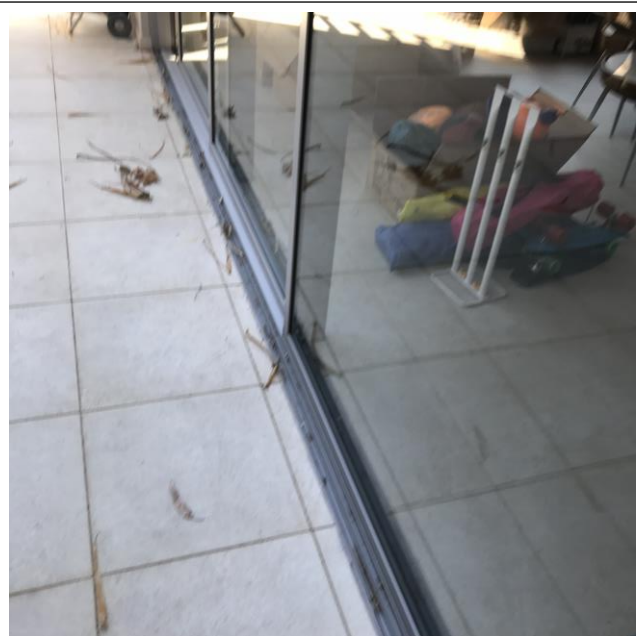
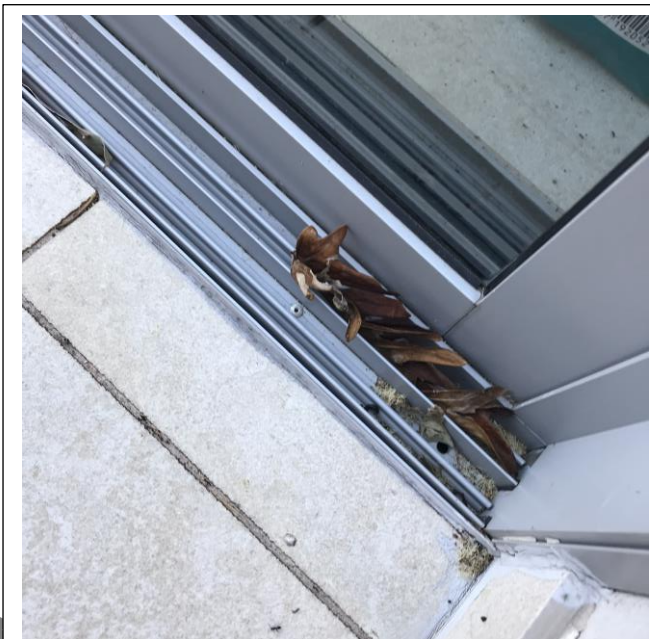
4.9.1a Sliding door to alfresco

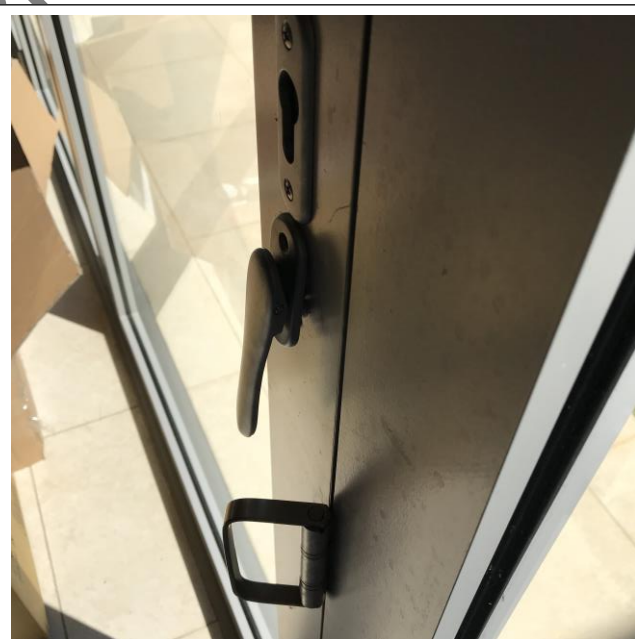
- a. Sliding door as above has possible issues with ingress of water.
- b. Bi-fold doors to the alfresco are in good working order but have a damaged handle to the centre door.

4.9.1b. Bi-fold doors

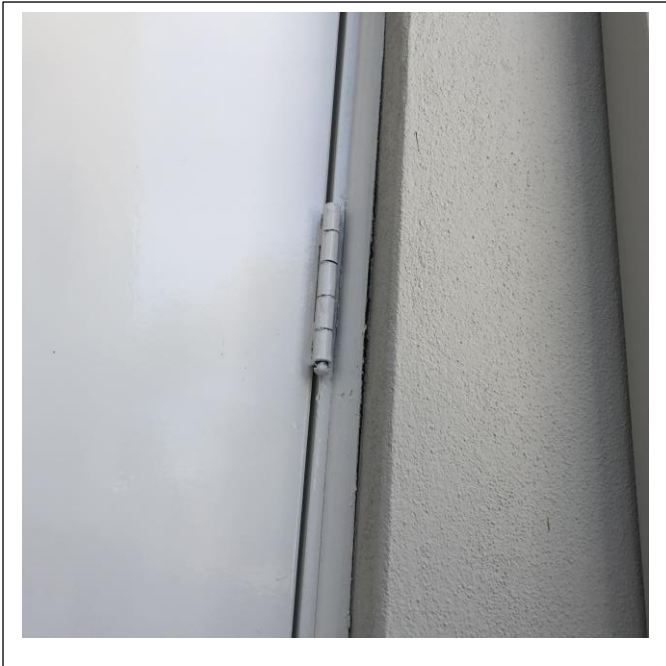
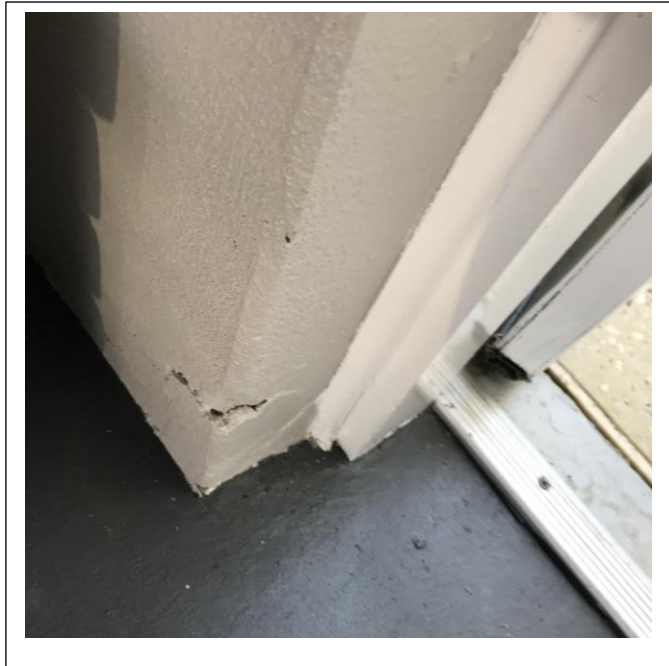
- a. The rear garage door frame hanging side appears to have moved away from the wall slightly. This has caused some damage to the render on the bottom inside of the garage. The cause may be due to it opening out over and being caught by the wind at some stage. This should be re secured using mechanical fixings to prevent further deterioration. The pin to the top hinge has been installed upside down.
- b. Some door frame buttons are missing which can cause door rattle. This is a minor issue and can be rectified through maintenance.
- c. Some door stops (bumpons) are missing these are easily installed and protect both handles and walls from being damaged.

4.10.1a Rear garage door

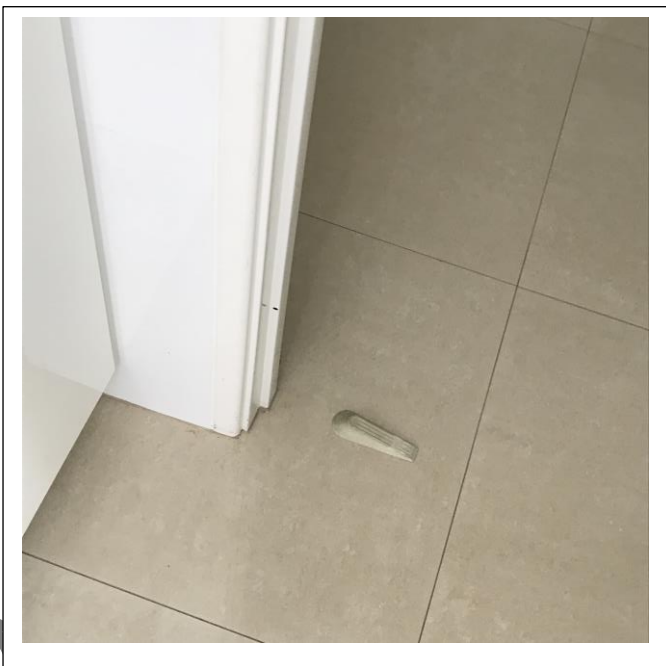
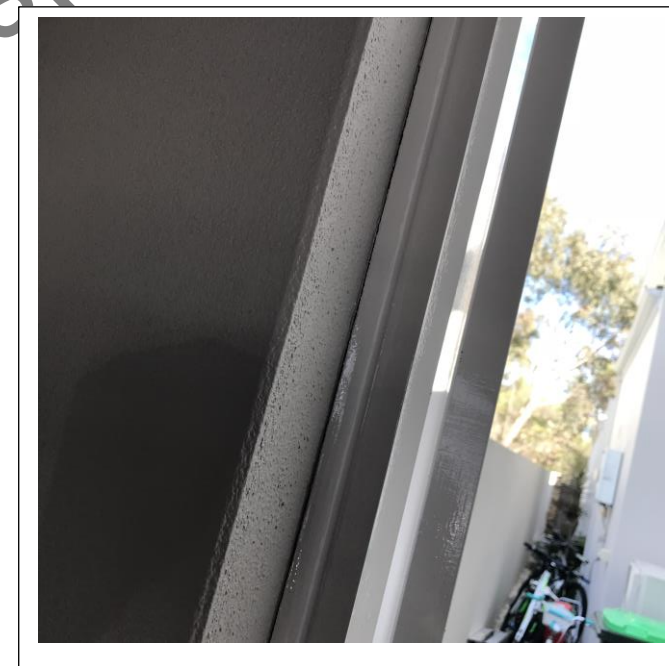
4.10.1b. Missing door frame buttons

4.10.1a from inside

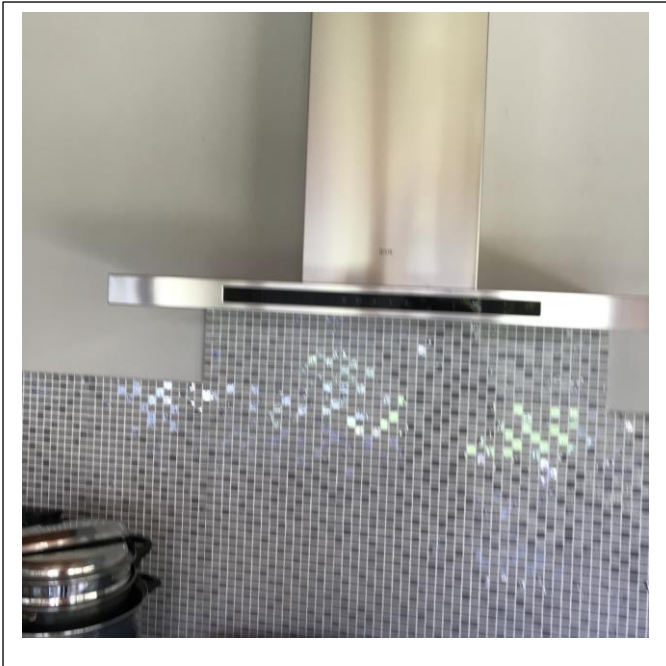
1. Cabinets – Above average
2. Bench Tops – Above Average
3. Sinks – No hot water to alfresco sink.
4. Appliances – Rangehood to the alfresco not operational at the time of the inspection.
5. Plumbing – No hot water to alfresco sink.

4.17.4. Rangehood to alfresco not operational

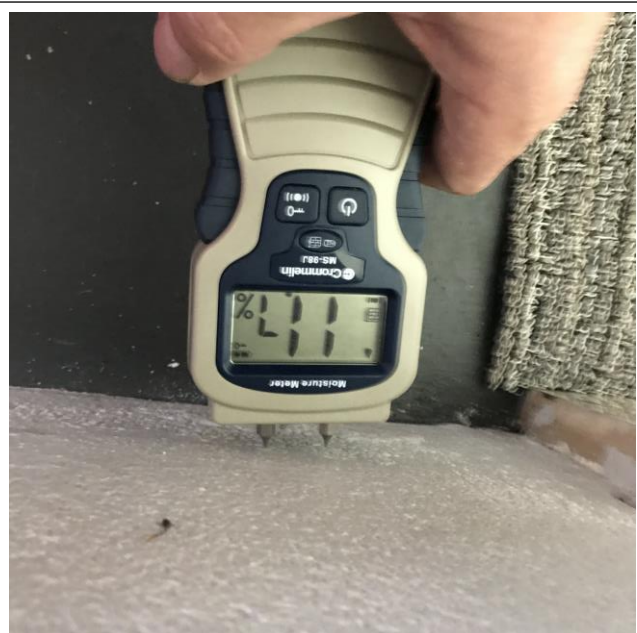
4.22.2. Dampness to garage wall near shopper door

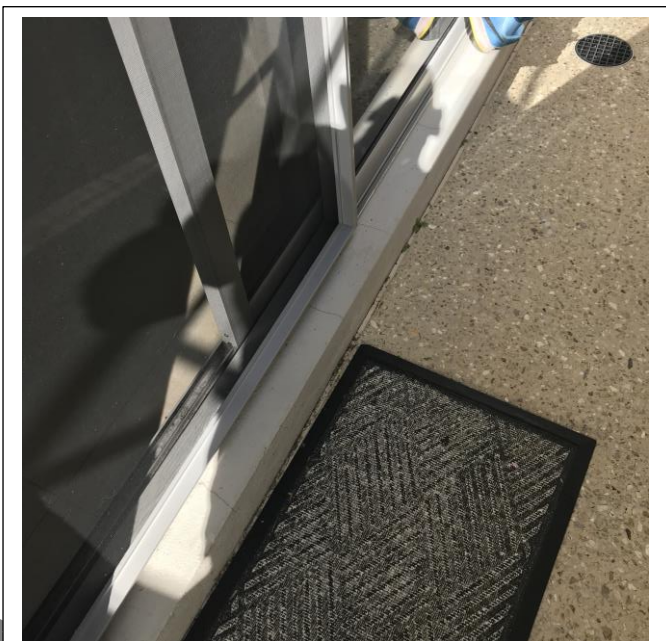
- a. Some minor cracking to the paving in front of the laundry but only caused by shrinkage and not deemed major.

4.31.1a Minor cracking to paving at laundry door.

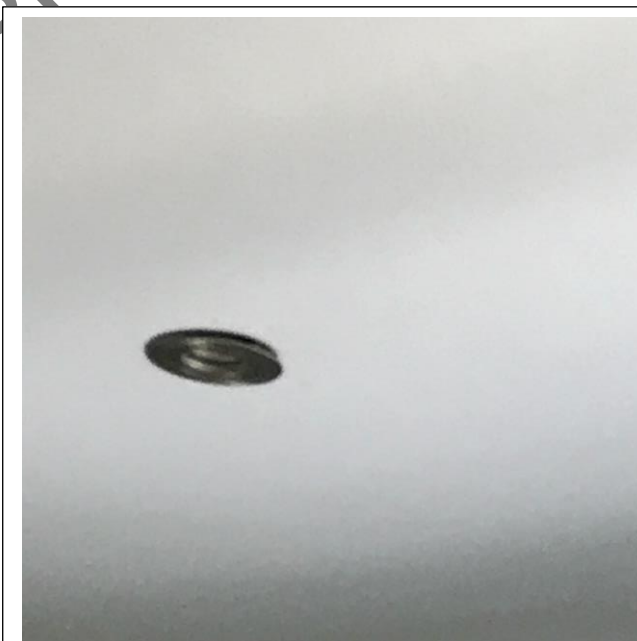
4.25.1a.Lights to office

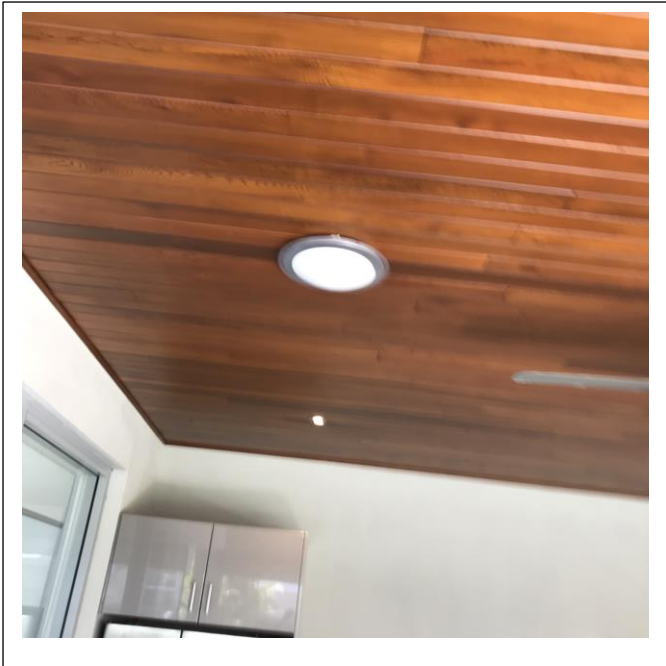
4.25.1b Light to alfresco.

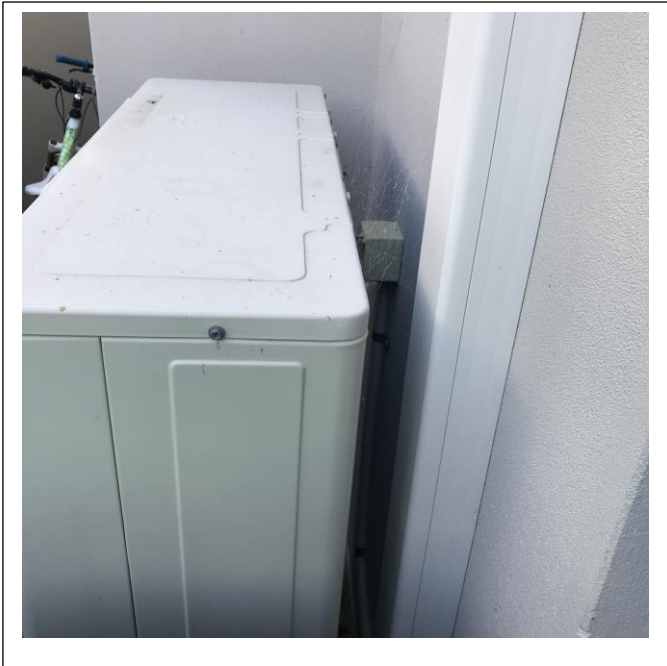
4.23.1a.No chains on air conditioning units

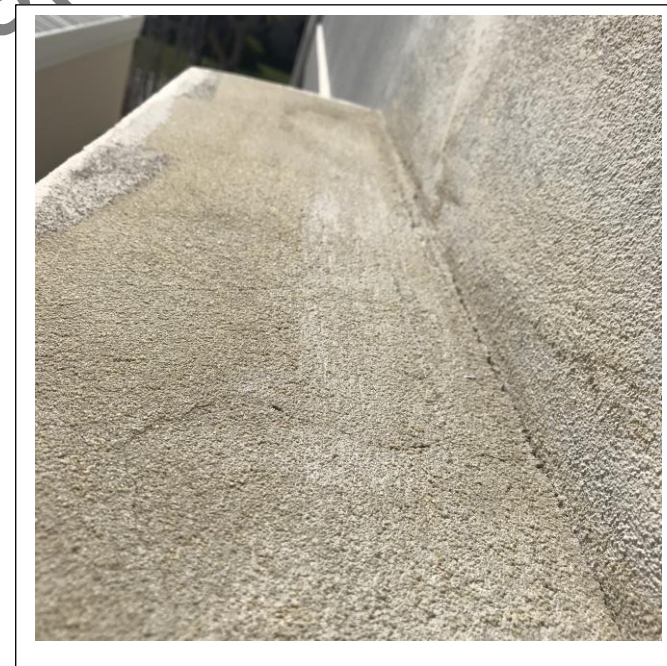
4.2.1e. Top of service stack not painted

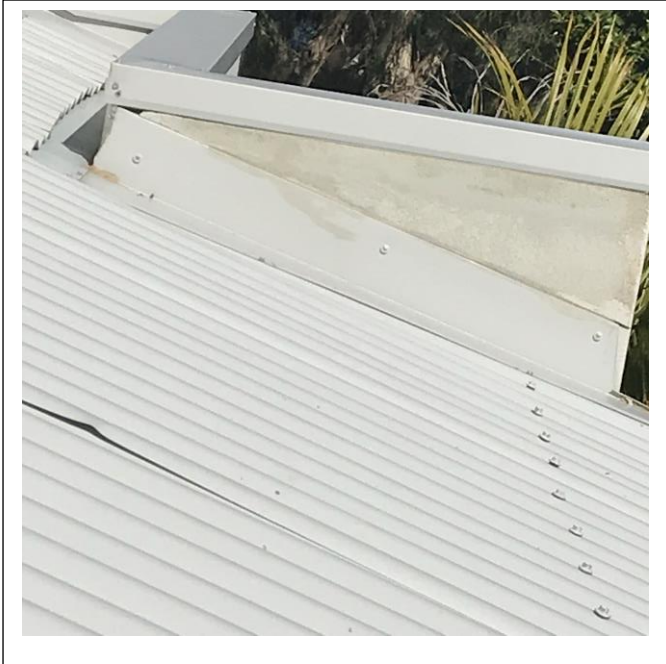
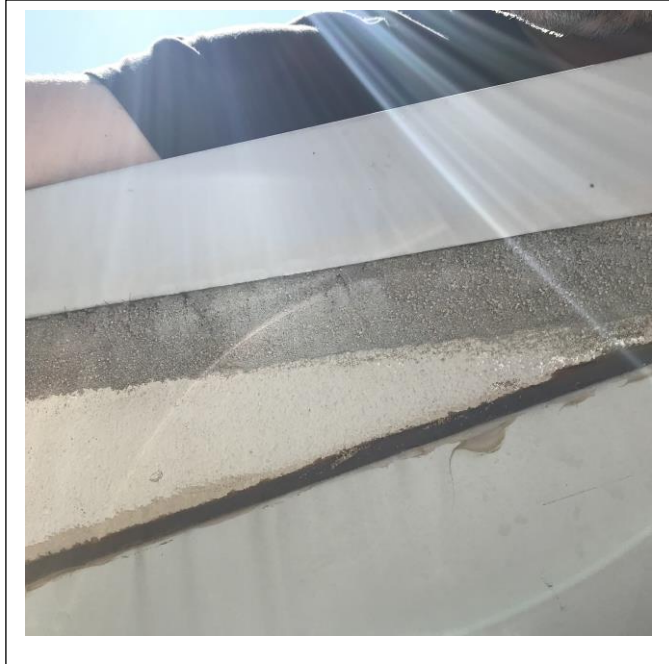
4.2.1e.Return nib to roof above lounge not painted

4.2.1e Ditto to opposite site of roof
